MCR-76-464 NAS8-31567 Final Report

STUDY OF SEM
INDUCED CURRENT AND
VOLTAGE CONTRAST MODES
TO ASSESS SEMICONDUCTOR
RELIABILITY

MARTIN MARIETTA CORPORATION P. O. Box 179
Denver, Colorado 80201

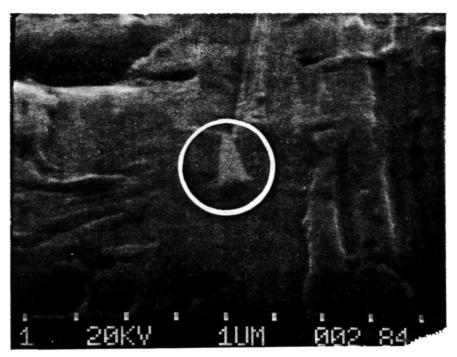
Figure 5. SE Micrograph Showing the Cone of Contamination (Circle) $E_B = 20 \text{ kV}$, $I_B = 1 \times 10^{-10} \text{A} \times 14000$

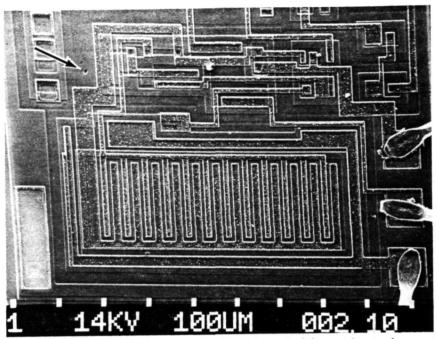
Figure 36. SE Micrograph Showing Oxide Defect (Arrow) in LM 111. ($E_B = 14 \text{ kV}$, $I_B = 1 \text{ x } 10^{-10} \text{A}$, Mag x 125.)

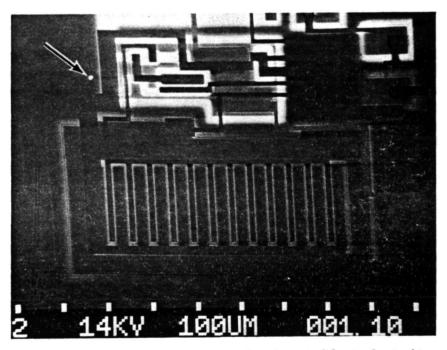
Figure 37. EBIC Micrograph Showing Oxide Defect (Arrow). (Same view as Figure 35. Current from Pin 8 with Pins 1 and 4 at ground. $E_B=14~\rm kV$, $I_B^{~~2}~1~x~10^{-10}\rm A$, Mag x 125.)

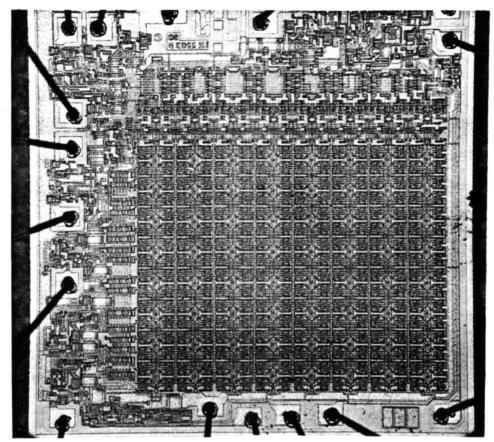
Light microscopic examination of the IM5523 die, 256 x 1-bit Ram identified over 10 possible oxide defect locations. The die is shown in Figure 41. Evaluation of this device, using EBIC, showed the suspected defects were not pinholes. Examination by SE imaging failed to show that they were surface blemishes. It appears that the suspected defects were subsurface flaws that did not significantly increase or decrease the oxide thickness. This device was further examined using the EBIC mode to locate a circuit anomaly. For a device of this complexity it is necessary to scan the device at 500 to 800X magnifications. At lower magnifications the EBIC image was too "busy" for cursory inspection and detection of an anomaly. Figure 42 shows the EBIC image for the complete die. In memory circuits there is a large amount of diffusion and circuit repetition. This provides a common image pattern and simplifies the recognition of variations and anomalies. The memory cell images were inspected using this method of examination. This resulted in the location of pinhole defects in the glass passivation. Figures 43 and 44 show the EBIC and SE images for these defects. The SE image indicates these defects were located in the glass passivation. It was extremely difficult to see these defects during subsequent rexamination by light microscopy at 620X using polarized light.

Figure 41. The IM5523 Die. (Examination by light microscopy had disclosed over 10 possible oxide defects. Mag x 50.)

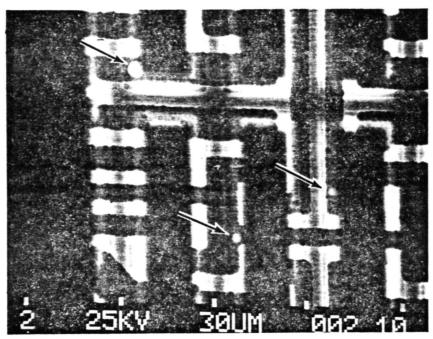
Figure 43. EBIC Micrograph Showing the Location of Three Pinholes in the Glass Passivation (Arrows).

(Current from Pin 16 with Pin 8 at ground.

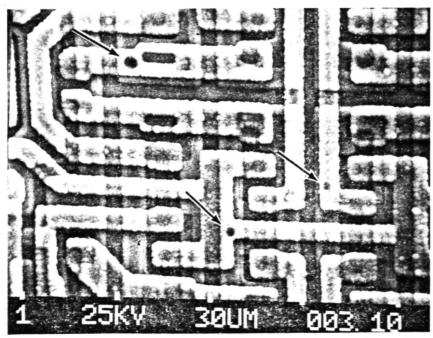
Figure 44. SE Micrograph of the Same Area Shown in Figure 43 Showing the Three Pinholes. (Arrows). (Mag x 850.)

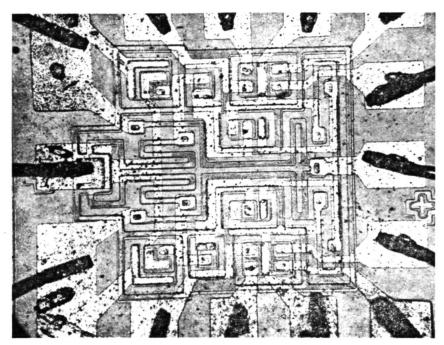
The DTL 930 die is not glass passivated. A photograph of the die is shown in Figure 45. Figure 46 shows one area in which junction non-uniformities or defects were observed. The EBIC image for this circuit is shown in Figure 47. This circuit was examined using several different EBIC pin sampling configurations. Figure 48 is an EBIC micrograph showing a part of one resistor. In this micrograph the defect sites are easily identifiable. The difference in image contrast between Figure 47 and Figure 48 was due to different current amplifier gain settings. In Figure 47 the current amplifier gain was set so the resistor signal level resulted in saturation of the current amplifier. In Figure 48 the gain was set to observe the variations in EBIC. An SE micrograph of the same area of Figure 48 is shown in Figure 49. These were found to be more difficult to detect with a light microscope or by SE imaging.

Figure 45. DTL930 Die. (Mag x 115.)

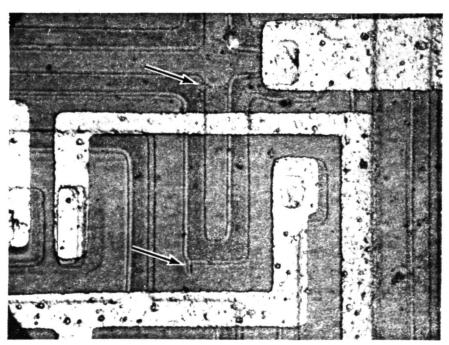
Figure 46. Visual Appearance of the Diffusion Defects Along a Resistor. (Arrows). (Mag x 500.)

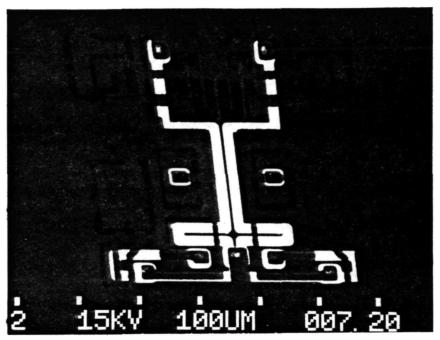
Figure 47. EBIC Micrograph of the DTL930 Die. (Current from Pin 7 with Pin 14 at ground. $E_B = 15 \text{ kV}$, $I_B \approx 1 \times 10^{-10} \text{A}$, Mag x 170.)

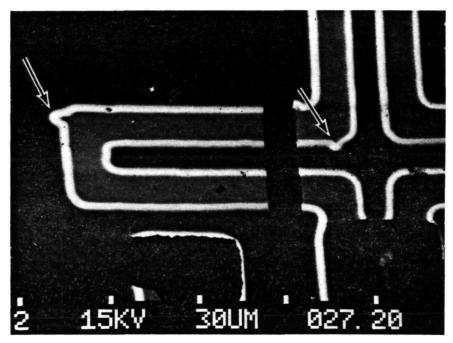
Figure 48. EBIC Micrograph Showing Two Diffusion Defects Along a Resistor. (Arrows). (Current from Pin 7 with Pin 14 at ground. $E_B=15~\rm kV$, $I_B\stackrel{\sim}{}1~x~10^{-10}\rm A$, Mag x~830.)

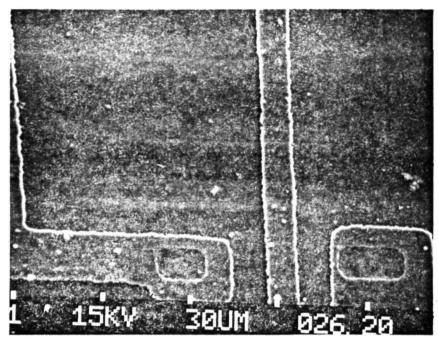
Figure 49. SE Micrograph of the Same Area Shown in Figure 48. (The defects have less contrast in this image. Mag x 830.)

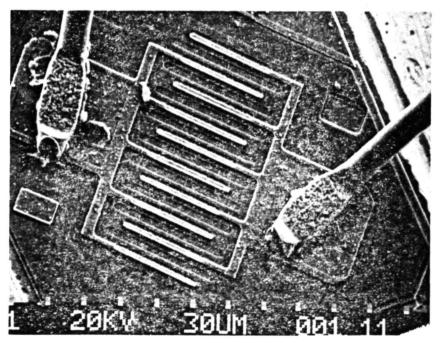
The 2N3921 die is glass passivated. See Figure 50. This device exhibited a high reverse leakage as a result of electrostatic discharge across the gate to drain junction. The $\mathbf{I}_{\overline{\text{GSS}}}$ leakage current measured 6.5 μA at V_{GS} = -30V. The I_{GSS} specification maximum is 350 pA at V_{CS} = -30V. This device was first examined using the standard EBIC configuration of source and drain connected to the current amplifier and gate at ground. The EBIC image was examined under various current amplifier sensitivities but a damage site could not be detected. The measured $I_{\mbox{\footnotesize GSS}}$ leakage current levels for this device were 18 pA for $V_{GS} = -0.5V$, 170 pA for $V_{GS} = -5.0V$, and 9 nA for $V_{CS} = -10.0V$. These data indicate that the beaminduced potential developed across the gate-drain junction was not sufficient to involve the damage site; therefore, the gate to drainsource junctions were externally reverse biased at $V_{GS} = -10.0V$. Reexamination of the EBIC image disclosed the damage site. See Figure 51. This EBIC micrograph shows the damage site as a low brightness spot (decreased EBIC current). The location of the site is in the N+ diffusion for the drain. See Figure 52. The decreased EBIC current indicates a decreased carrier lifetime that

Figure 50. SE Micrograph of the 2N3921 FET Die. (Mag x 350.)

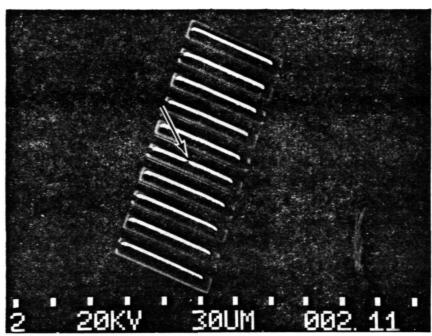
Figure 51. EBIC Micrograph of the Same Area Snown in Figure 50. ($V_{GS} = -10 \text{ V}$. Damage site is visible (Arrow). ($E_B = 20 \text{ kV}$, $I_B \approx 1 \text{ x } 10^{-10} \text{A}$, Mag x 350.)

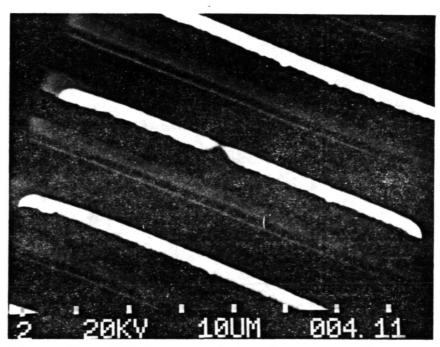
Figure 52. EBIC Micrograph Showing Damage Site at Increased Magnification. (Same conditions as Figure 51. Mag x 1500.)

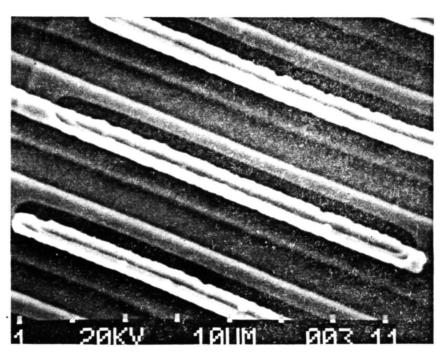
Figure 53. SE Micrograph of the Same Area in Figure 52. (No evidence of a damage site is visible. Mag x 1500.)

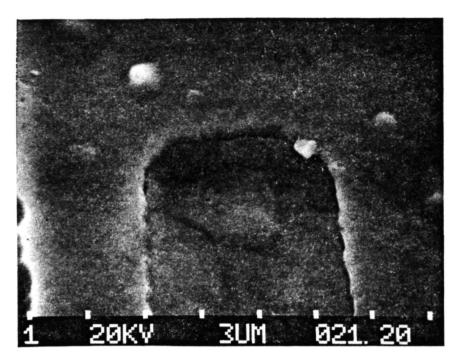
Figure 64. SE Micrograph of Resistor Contact Window on a DTL 930 Circuit. (Mag x 5400.)

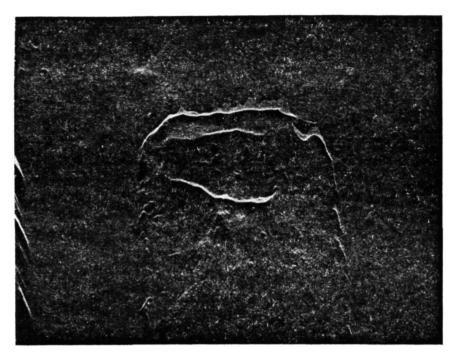
Figure 66 shows a Y modulation EBIC micrograph of this area. Note the "knife edge" along the oxide step. Film thickness measured along the step indicated a film thickness decrease of approximately 25%. This does not necessarily imply the metal thickness has only decreased 25% because SiO_2 may be present under the step area. SiO_2 has a density very similar to aluminum; therefore, great care must be exercised in taking these measurements.

Figure 66. Y Modulation EBIC Micrograph of Same Area Shown in Figure 64. (Current from Pin 14 with Pin 7 at ground. E_B = 20 kV, I_B * 1 x 10⁻¹⁰A, Mag x 5400.)

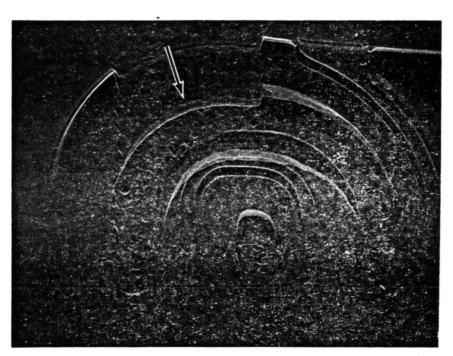
A 2N5196 junction FET provides a second example of metalization coverage at an oxide step. Figure 67 shows a SE micrograph of this step. Figure 68 is an EBIC micrograph of this area and Figure 69 is a Y modulation EBIC micrograph. The "knife edge" can be seen in this micrograph also. Figure 70 shows an EBIC line scan superimposed on the SE image. Figure 71 is a SE micrograph of the step area at X10,000.

Figure 69. Y Modulation EBIC Micrograph of Same Area and Conditions as Shown in Figure 68. (The oxide step is located by arrow. Mag x 1000.)

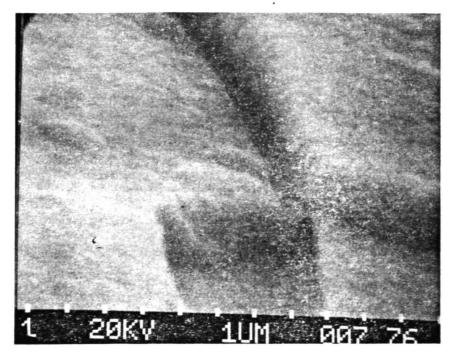
Figure 71. SE Micrograph of Metal Coverage at this Oxide Step. (Mag x 10,000.)

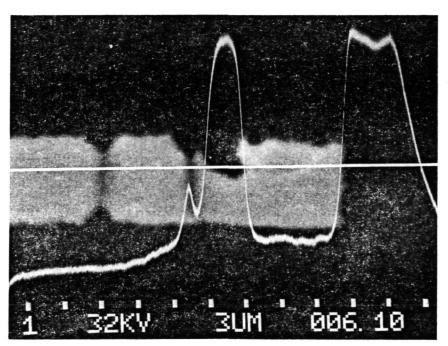
Figure 73. EBIC line scan Superimposed on SE Image. (This shows the relative EBIC current variations for the Au metallization. Current from Pin 11 with Pin 4 at ground. $E_B = 32$ kV, $I_B = 1 \times 10^{-10}$ A, Mag x 3600.)

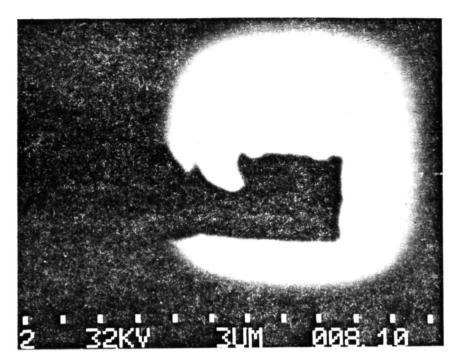
Figure 74. EBIC Micrograph of Emitter Diffusion. (This shows why only one oxide step transition can be seen in Figure 73. The other is located over the base region where EBIC is not being measured. Mag x 3600.)

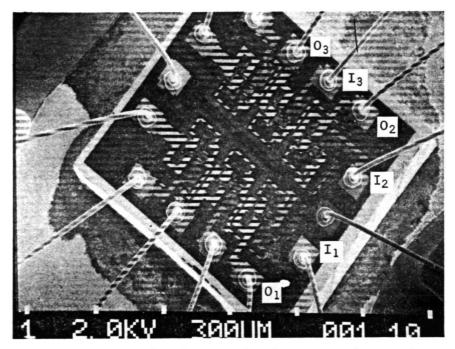
The combination of voltage contrast and EBIC provides a powerful tool for failure analysis. A 54LO4 TTL Hex Inverter is used as an example. This has a glass passivated die with Au metalization. The inputs for three inverters were subjected to a simulated electrostatic discharge. Figure 80 shows all six inverters are functional at the nominal V_{cc} of 5 V. Electrostatic discharge stress has historically resulted in failure to function at low temperature. Many high and low temperature functional anomalies can be disclosed by increasing and decreasing circuit supply voltages. The $V_{\rm cc}$ level was decreased to 4 V and circuit 1 (pins 2 & 3) failed to function (Figure 81). The $\rm V_{\ \ cc}$ level was further reduced to 2.5 V and all three of the stressed inverters failed to function (Figure 82). The isolation of the failure site was made for circuit 1. Figure 83 shows the normal operation of circuit 1 at $V_{cc} = 5 \text{ V}$. Figure 84 shows the failed state at $V_{cc} = 4 \text{ V}$. Figures 85 and 86 are EBIC images of the failure site in the base/ emitter junction of the phase splitter transistor. This damage resulted in decreased beta for the phase splitter transistor. This is one example demonstrating the use of SEM applications for failure isolation and defect location without the need for glass passivation removal or mechanical probing of the die surface. damage sites for the remaining circuits were also located using these same techniques. These defect sites could not be detected by light microscopy examination.

Figure 80. SE V/C Micrograph of 54L04 T/L Hex Inverter. (All six inverters were functioning with V_{CC} = 5 V. E_B = 2 kV, Mag x 60.)

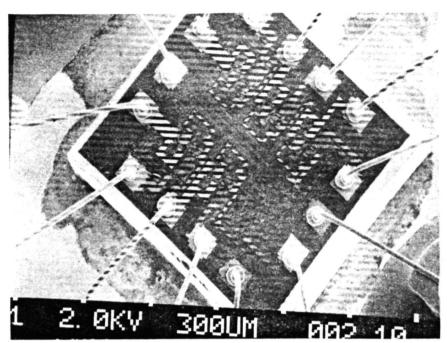
Figure 81. SE V/C Micrograph with $V_{CC} = 4$ V. (Inverter 1 has stopped functioning. $E_{B} = 2$ kV, Mag x 60.)

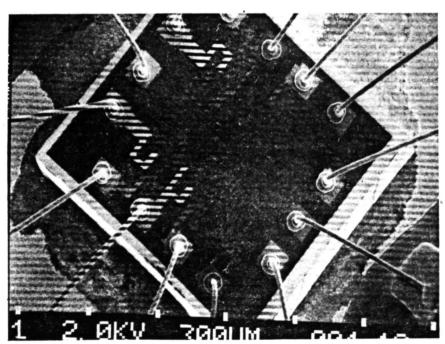
Figure 82. SE V/C Micrograph with V = 2.5 V. (Inverters 1, 2 & 3 have stopped functioning. $E_B = 2$ kV, Mag x 60.)

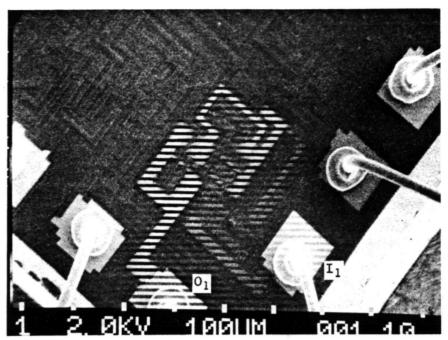
Figure 83. SE V/C Micrograph of Circuit 1 with $V_{CC} = 5$ V. (Normal circuit function. $E_B = 2$ kV, Mag x 130.)

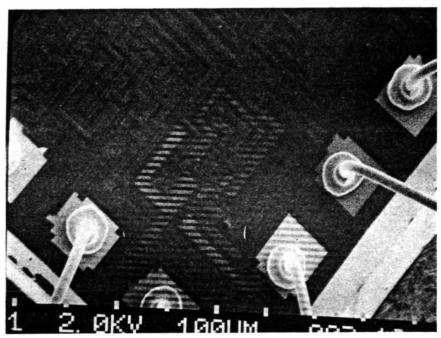
Figure 84. SE V/C Micrograph of Circuit 1 with $V_{cc} = 4 V$.

(Circuit output is not functioning. $E_B - 2 kV$,

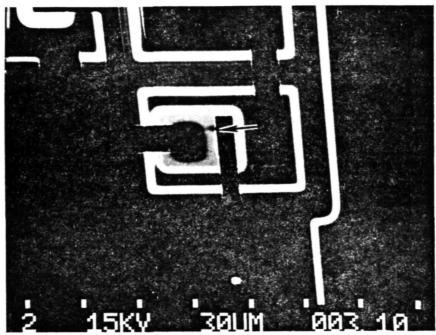
Figure 85. EBIC Micrograph of Circuit 1 Showing Damage in Base/Emitter Junction of Phase Splitter Transistor. (Current from Pin 4 with Pin 11 at ground. $E_B = 15$ kV, $I_B \approx 1$ x 10^{-10} A, Mag x 500.)

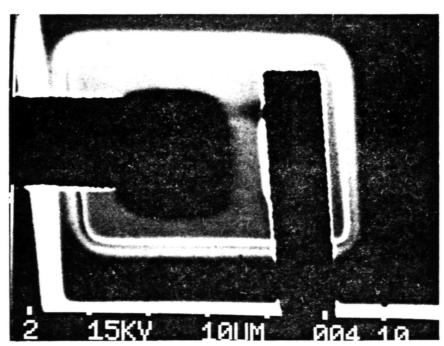
Figure 86. EBIC Micrograph of Same Transistor in Figure 85 at Increase Magnification. (Mag x 1600.)
